II. Physical Description

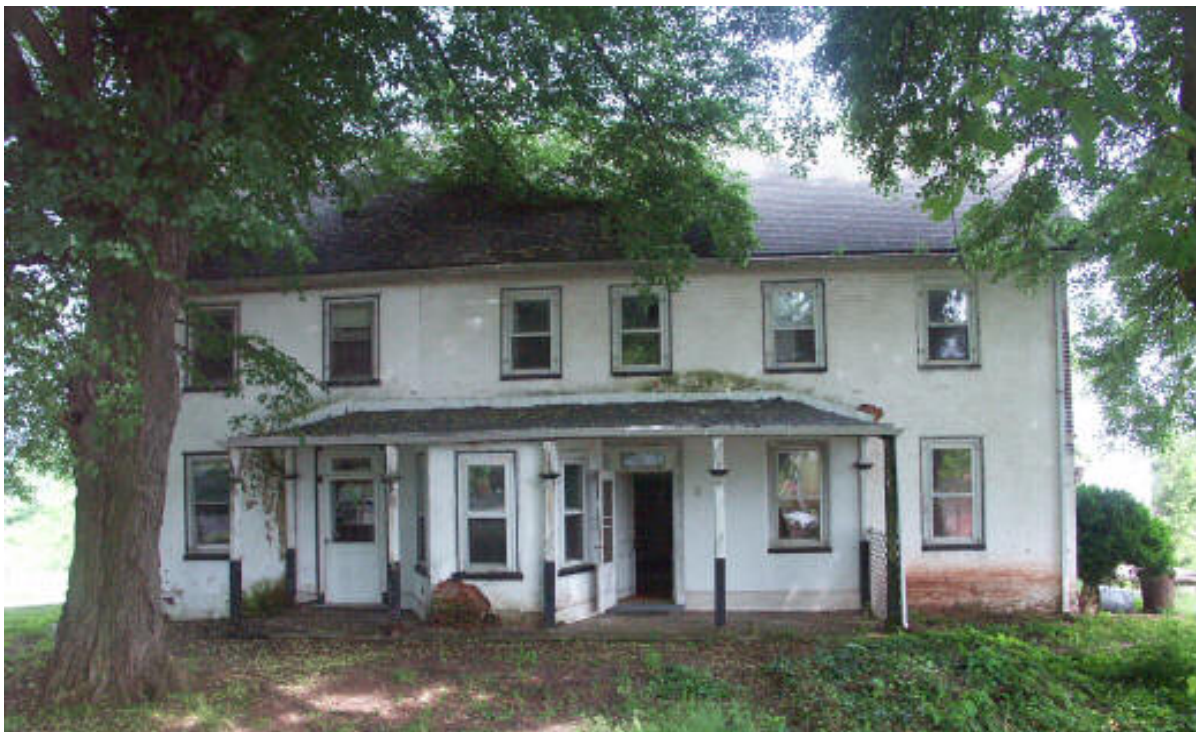
Photo 1. Hunsicker House, west elevation.

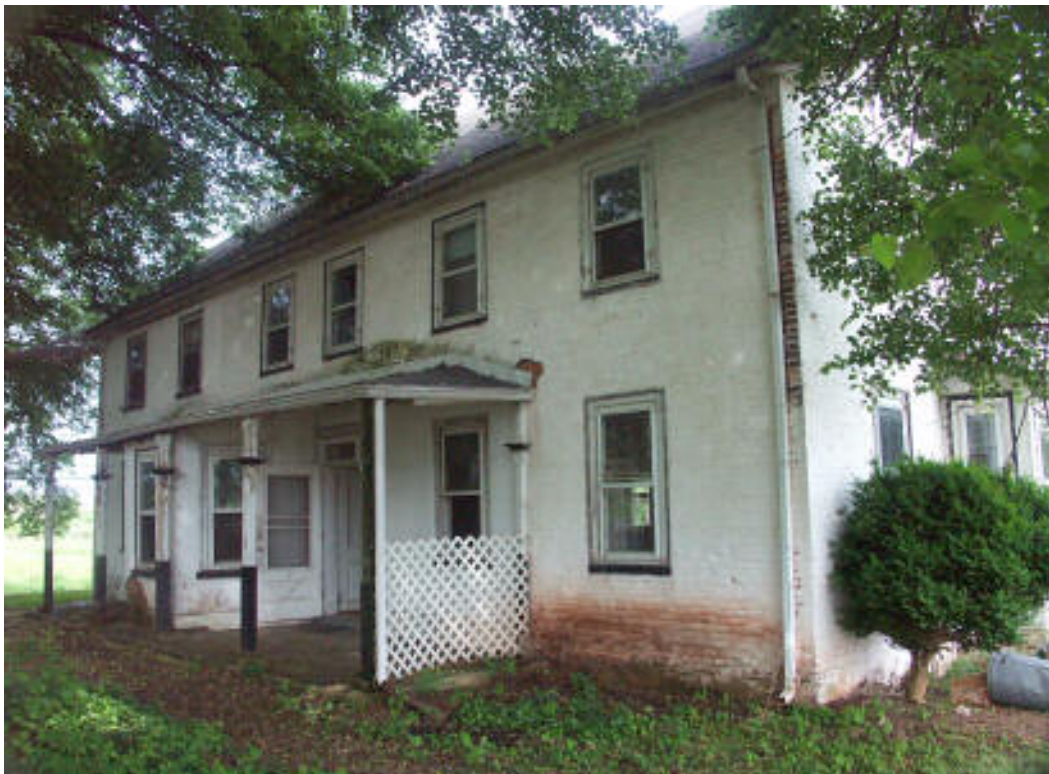
Photo 2. West and part of south elevations of House.

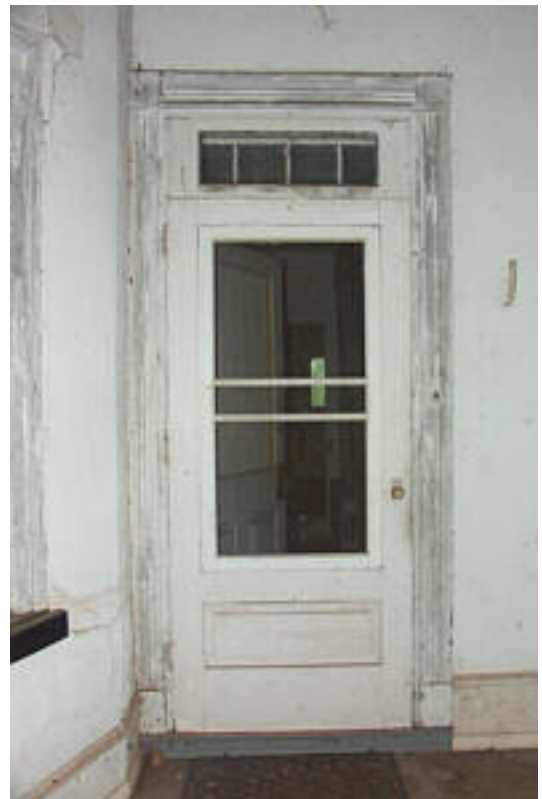
There are two entrances on the west elevation of the main block. The primary entrance is located just south of the bay window (Photo 3). A Greek Revival Style door surround (consistent with the age of the house) consists of a bulls-eye in the upper corners, a fluted jamb and lintel board, and a simple base. A four-light transom is located over the door. The door itself has a window above the lock rail and two panels below.

Photo 3. Main entrance, west elevation.

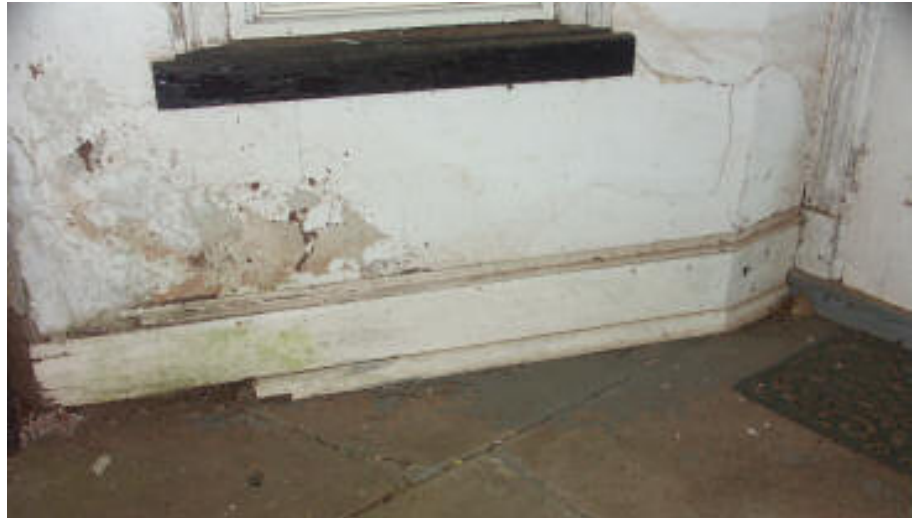
Along the base of the wall surface under the porch, a late-nineteenth century spiked baseboard molding is installed on the exterior (Photo 4). The molding also runs around the bay window, and an area of failing brick on the bay window has an exposed nailing board in the brick wall, indicating that the molding was installed at the time the bay window was constructed.

Photo 4. Exterior baseboard molding on porch, west elevation.

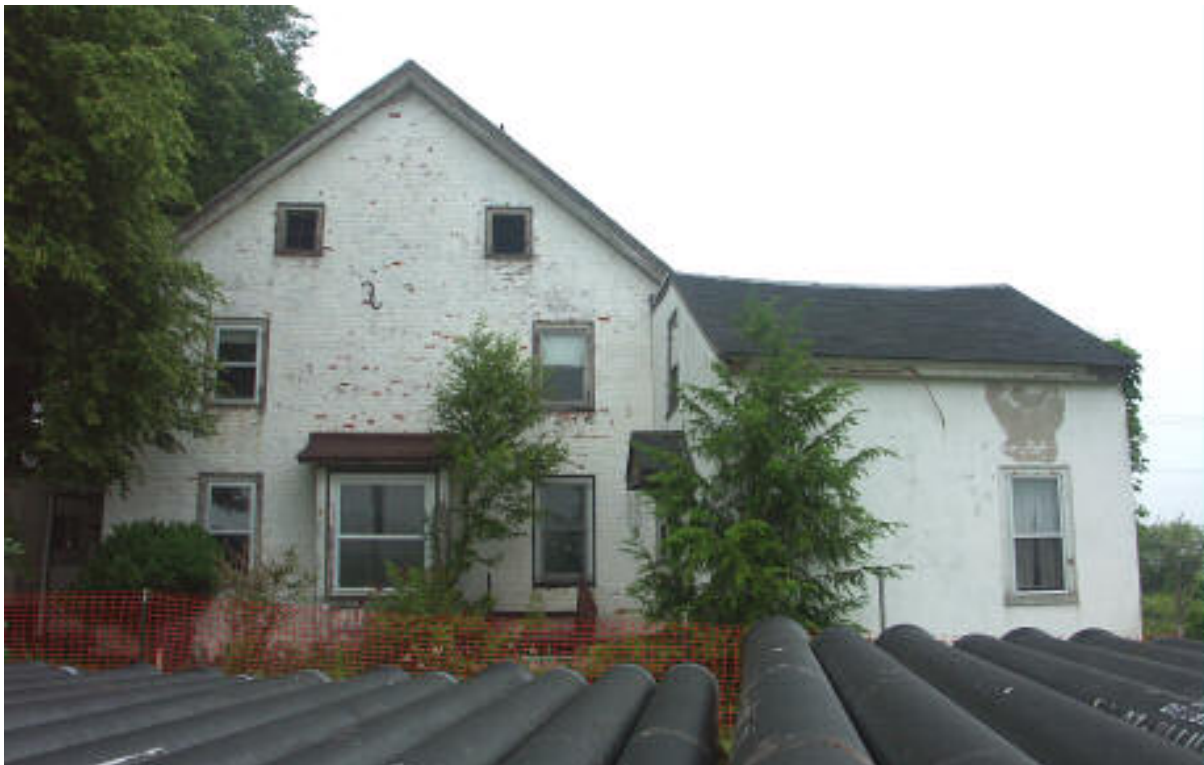
Photo 4a. South elevation of house, showing the main block (L) and the south section (R).

The south end wall of the main block (center section) retains many of the characteristics of the west elevation of the center section. The molded cornice is highly visible on this wall and features a cornice return (Photo 6). The painted brick wall has several areas of damage, with some brick in need of replacement. Fenestration is roughly symmetrical. The first floor has a rectangular bay window flanked by windows, and the second floor and attic level have two windows. The early twentieth century bay (Photo 5) is a 6'x3' element with a shed roof and a brick foundation. Below the window on each panel is an area of flush vertical siding. [Note: It is unclear what was originally located here. The presence of the chimney suggests that a fireplace was located on the first floor, but there is no evidence of a hearth support in the basement. It is possible that a heating stove was vented through a chimney corbelling out from the wall here. Markings on the exterior wall indicate that a porch was once located here, shading a door.] It has a large window unit on its south panel and smaller windows on the end panels. Windows on the first and second floors are 1x1 replacement units with the double-beaded frame and pintles. Attic windows are four-light units hinged on one jamb. The bulkhead to the basement is located east of the bay window.

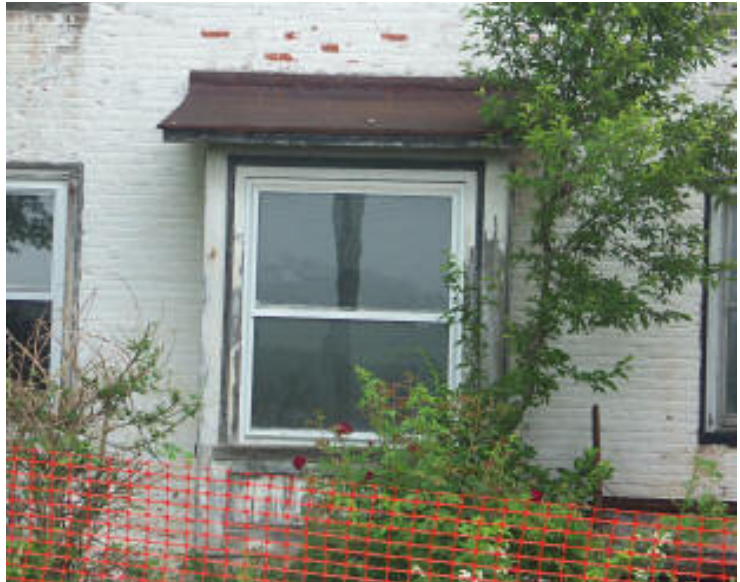
Photo 5. Bay window on south end of center section.

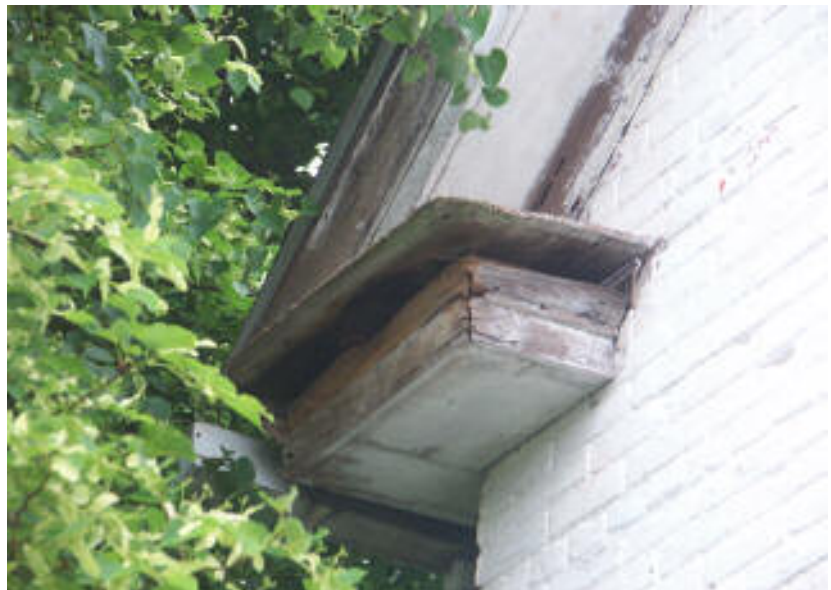
Photo 6. Detail of deteriorating cornice on south end of center section.

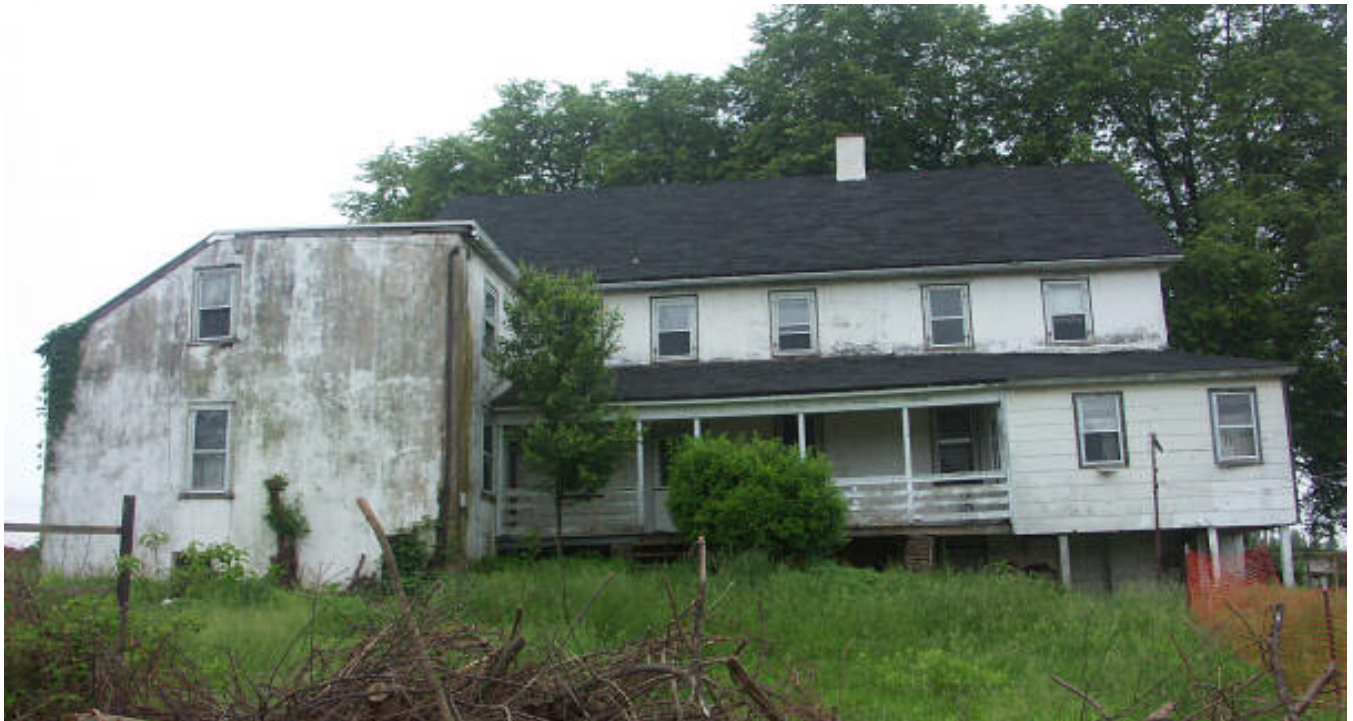
Photo 7. East elevation of House, showing south section (L) and main block (R) .

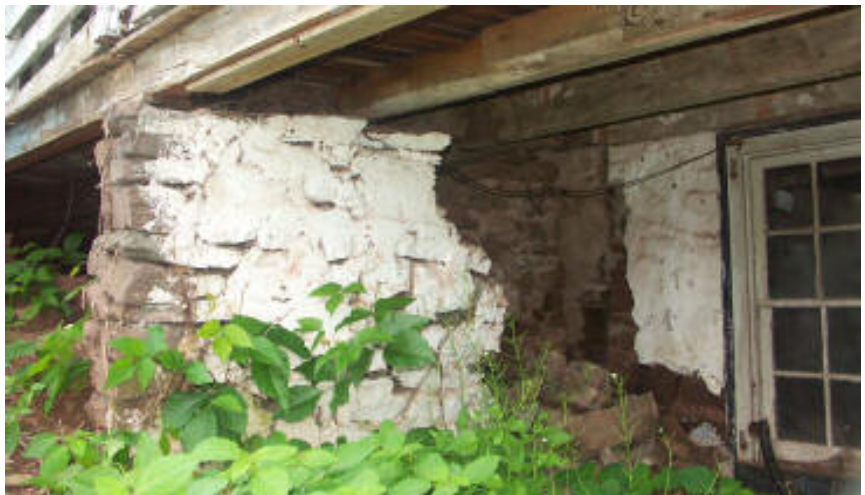
Photo 8. Stone wall supporting porch on east elevation; note structural failure.

chamfered columns support the ends of the roof, and the columns are connected by a series of four rails. The floor is narrow tongue-and-groove boards. A stone wall originally constructed as a foundation (Photo 8) is leaning to the north and no longer serves the purpose.

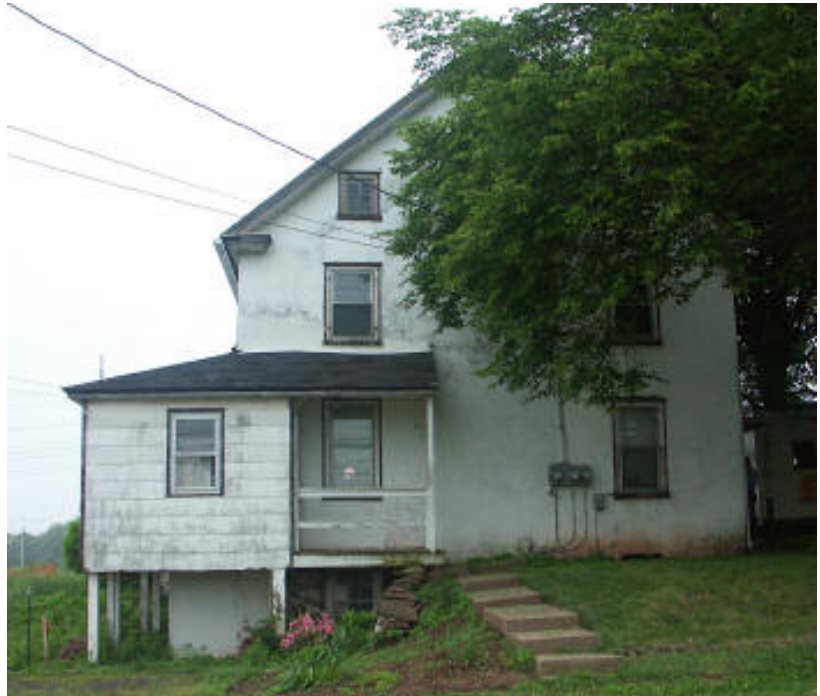
The cornice retains the molding pattern of the center section and includes similar cornice returns on the north end wall. When the north section was constructed, the builders used the same cornice molding as that on the center section. The splice is visible on both east and west elevations. Windows are aligned on the first and second floors, and the smaller four-light attic windows (original units) are only slightly shifted to the center of the elevation. A portion of the frame section wraps around the northeast corner, covering a small part of the north elevation. Under the frame section, part of the foundation wall is visible (Photo 10). Here, a 6x6 basement window (which appears to be original) indicates the type of window probably found throughout the north section at the time of its construction. This window has an early-to-mid nineteenth century muntin profile.

Photo 9. North elevation of House. Frame section on left.

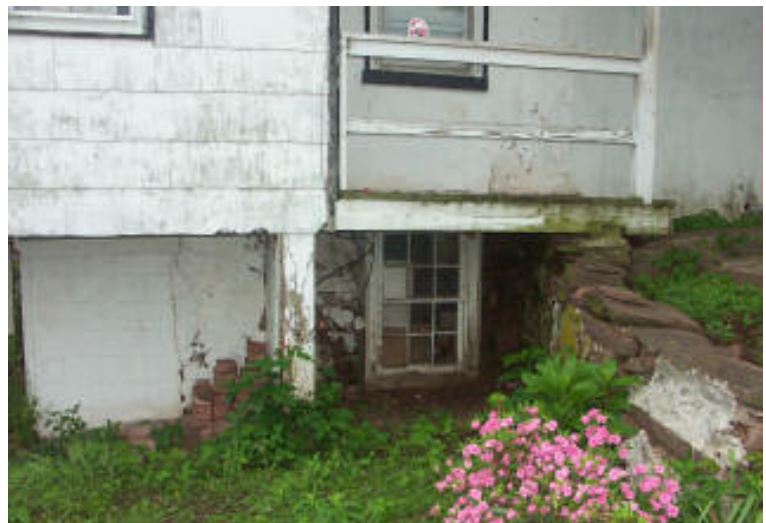
Photo 10. Detail of porch on north end of north section over original basement window.

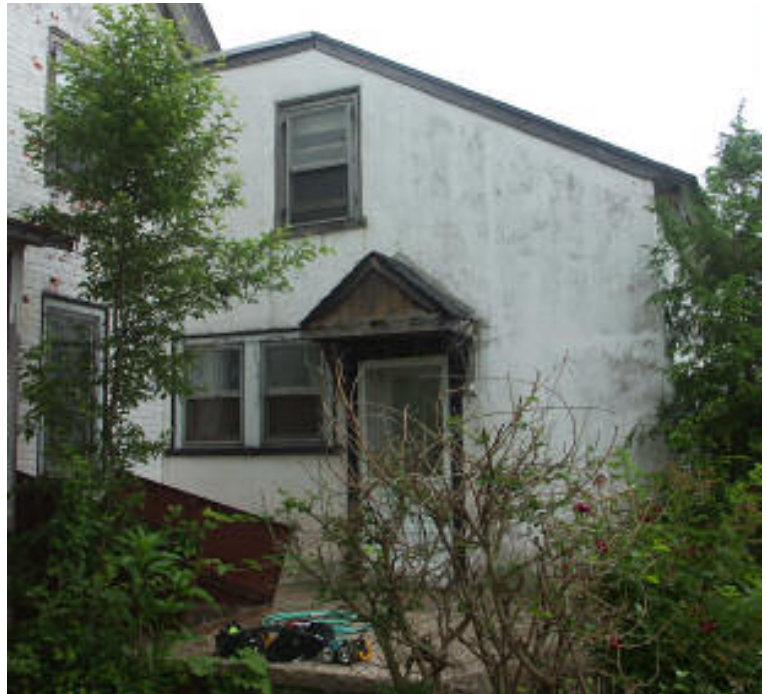
Photo 11. West elevation of south section.

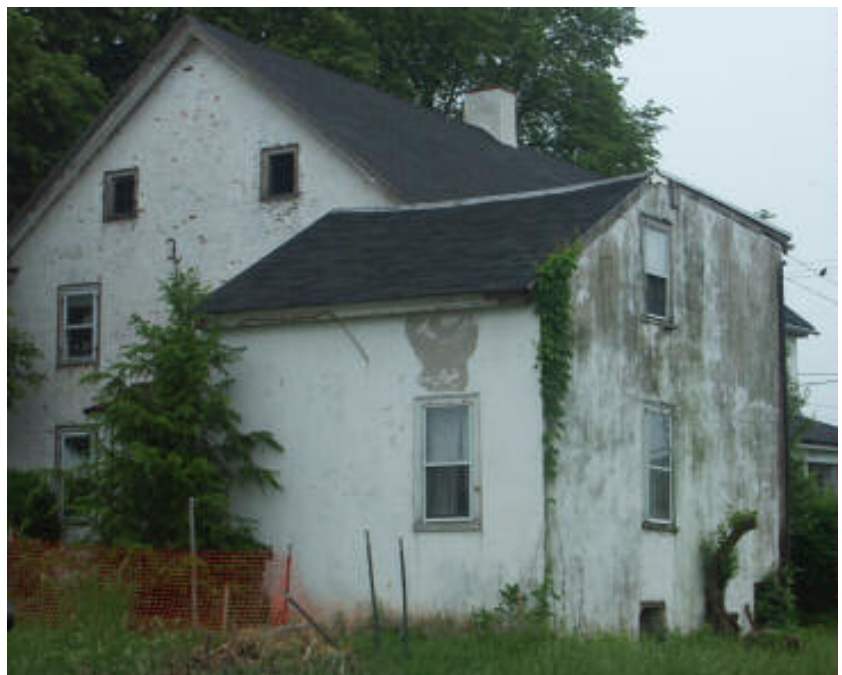
Photo 12. South section, facing northwest. The area under the flatter roof extent is the Connection.
