Attic

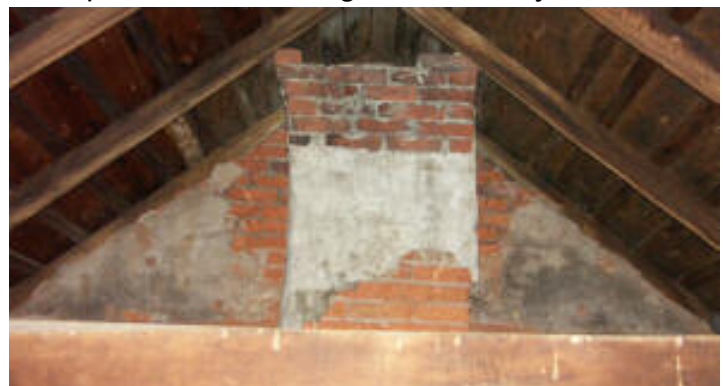
Photo 28. Chimney, south end of main block.

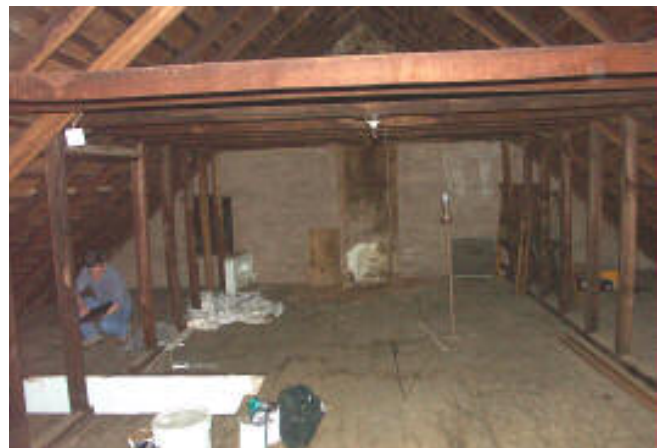
Photo 29. Interior of attic, center section.

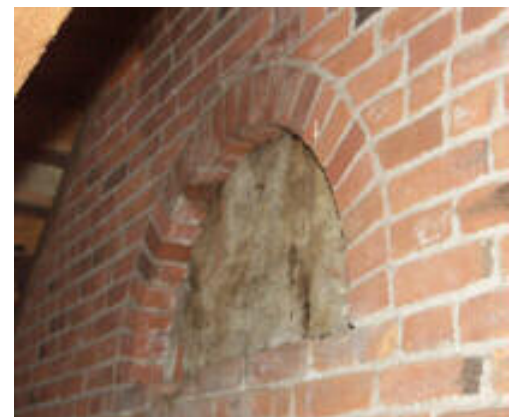
The attic has three gable walls: the two brick gables of the center section and the stone wall of the north section. An examination of the north gable of the center section provides several clues that it was originally an exterior element. The north side of the wall has exterior mortar between the brick and a semi-circular datestone area. An iron tie rod has an S-shaped iron head and is located below the location of the datestone (Photo 30); the datestone is missing. The garret windows on the end walls are 4-light units hinged on one jamb. The attic windows on the two end walls of the center section are not aligned, although the attic windows in the north section are aligned with those of the north wall of the center section. Although the attic windows are quite old, they do not appear to be original to the sections.

Photo 30. Datestone area, north wall of center section, visible in attic of north section. Note exterior pointing of brick.
