## IV. Condition Analysis

Overall, the house is in fair to good condition. While the house was not examined by a structural engineer, it appears to be structurally sound. The water conduction system warrants immediate attention. While the roof is relatively sound, the water conduction has failed, helping to make the house extremely damp, especially in the basement and the entire north section. Other key areas of failure are the woodwork, particularly the cornice molding and window surrounds, as well as the deterioration of many brick in the center section. The damp basement has contributed to the fair to poor condition of the joists supporting the flooring above. Furthermore, birds, bats, and insects inhabit the cornice system and attic. While all these issues would be addressed in a restoration / rehabilitation, those such as the water conduction and overall dampness should be addressed immediately. A more specific analysis follows, described by section.

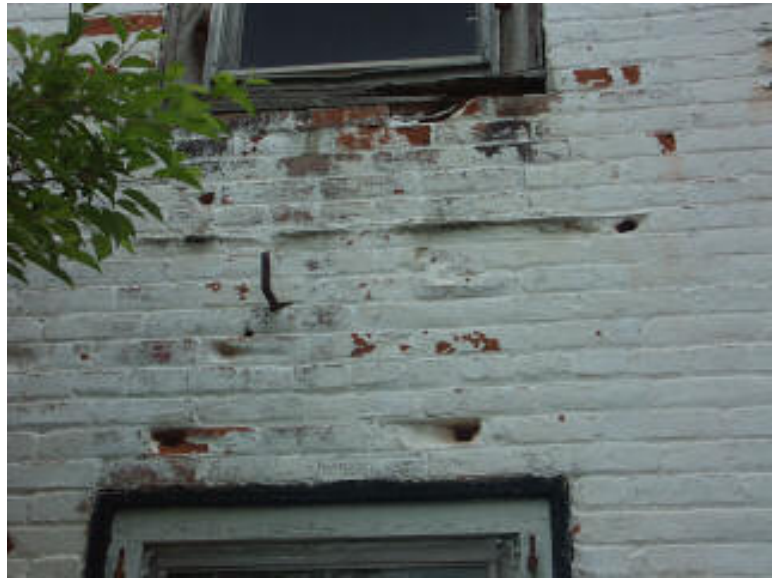
6. The condition of the brick walls needs to be addressed. The house was constructed with lesser quality brick. Many of the bricks have lost their patina and are exfoliating (Photo 36). One repair option would be to use a compound to fill holes in the brick, re-point with soft mortar as necessary, then re-paint the entire surface. This process would result in the paint serving as the exterior material rather than the brick and should prolong the life of the brick. Another repair option, of course, would be to replace the most damaged brick.

**Photo 36. Deteriorating brick on south wall of main block.**

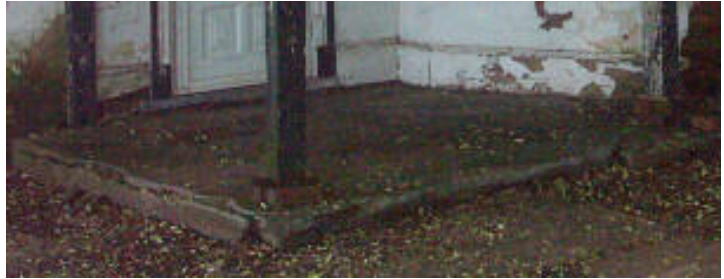
- c. The pilaster under the northeastern corner of the porch has separated from the wall surface.
- d. The concrete pad is in fair condition. Its arris has weathered and has lost its sharp edge (Photo 36a). In many places, its edges have broken. Furthermore, towards its north end, the pad has sunk two inches. The pad is not original and should be replaced with a frame porch.

**Photo 36a. View of the concrete pad on the porch, west elevation, showing deterioration.**

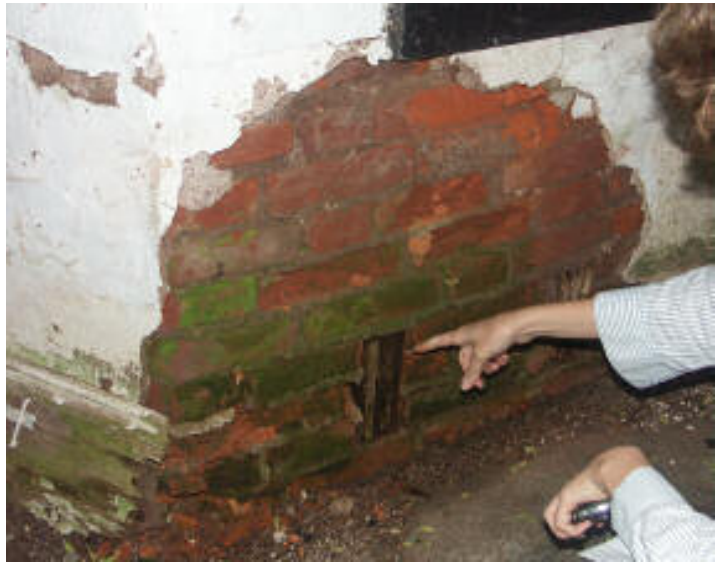
- e. The wall of the center section under the porch roof needs to be re-stuccoed. A large section of the stucco is completely missing on the bay, allowing the exposed soft brick to deteriorate (Photo 36b). Several cracks appear in the brick bay, two of which appear to be structural. If the bay is to be retained, the structural cracks should be addressed, followed by a re-application of scored stucco.

**Photo 36b. Damage on the west elevation of bay window.**

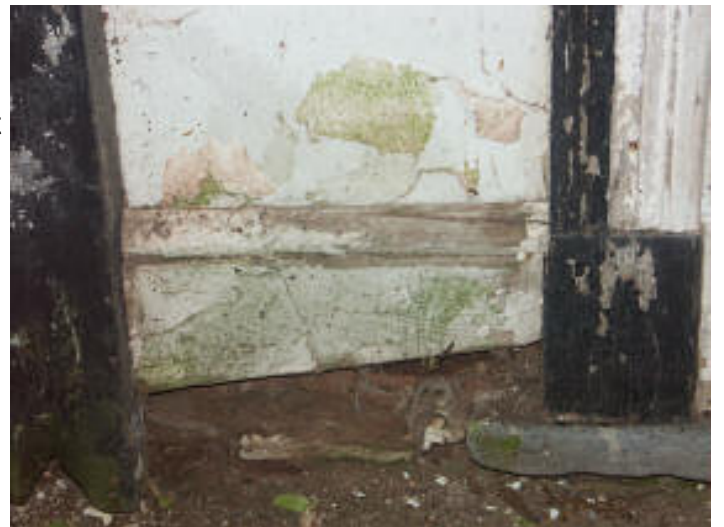
- f. The high baseboard molding found along the wall surface needs repair and/or replacement. The northernmost section,

**Photo 36c. Damaged baseboard molding on exterior wall, porch on west elevation.**

between the door and the northern pilaster, has completely separated from the wall and should be replaced. Other sections of the baseboard molding appear in better condition, although the base shows some signs of water damage. This molding should be replaced if the bay window is to be retained.

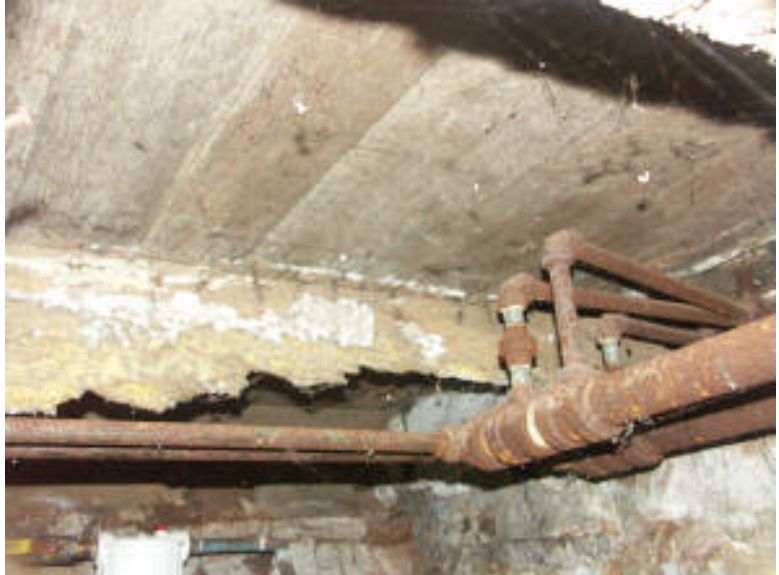
**Photo 37. Damaged joist in center section, facing south.**

- c. If the frame section is to be removed, the porch should be extended along the entire east elevation of the main block.
15. In the basement, many of the joists have suffered damage and will need to be replaced (Photo 37). This is a priority, as its current condition may be structurally unsound.

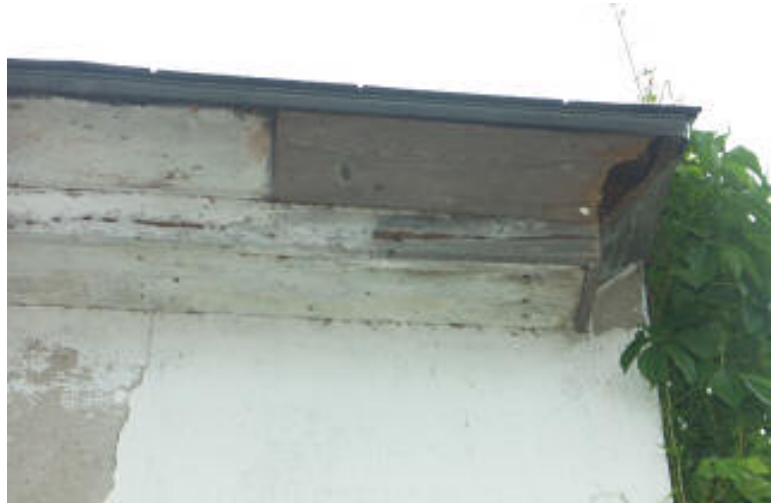
3. The cornice system needs repair. The bargeboards are broken in several places, with sections missing on each elevation (Photo 38). The resulting water damage is visible on the interior (Photo 39).

Photo 38. Damage to the cornice, south section.

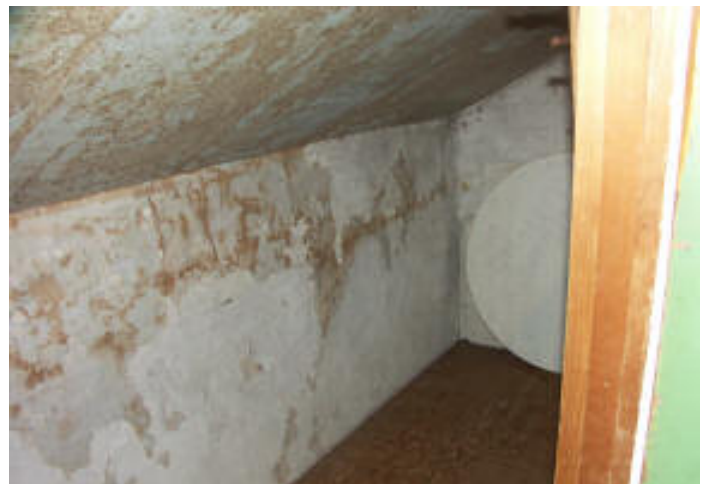
Photo 39. Dampness in attic of south section.

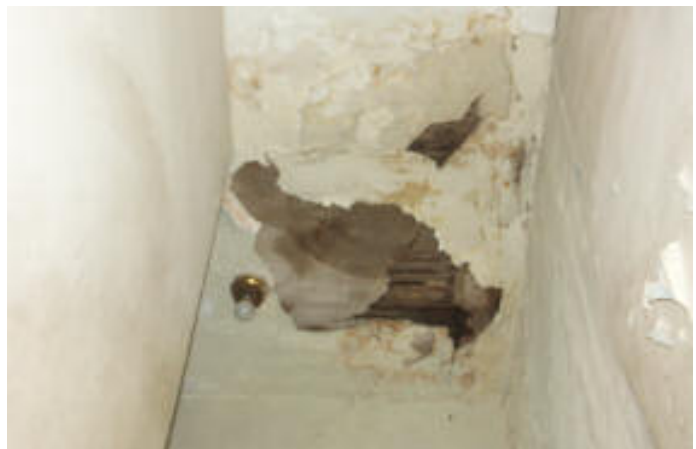
1. There is a major leak originating near the northeast corner of the section. This has destroyed plaster in the interior and is allowing dampness and rot into the building envelope.

Photo 39a. Water damage in the hallway of the south section.
