The Hunsicker House: Preliminary Structure Report (2/23/04)

Robert Wise and Seth Hinshaw, Preservation Planners with Wise Preservation Planning, examined the Hunsicker House on February 18, 2004 with members of the Skippack Historical Society. The goals of the visit were to:

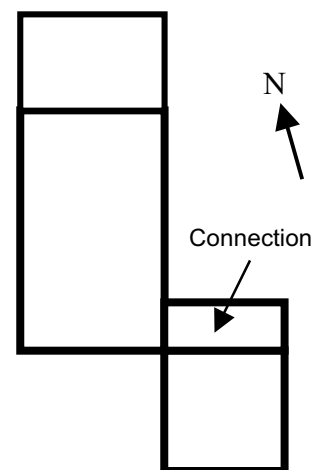
Sections of the house.
