## Interior Description

### First Floor

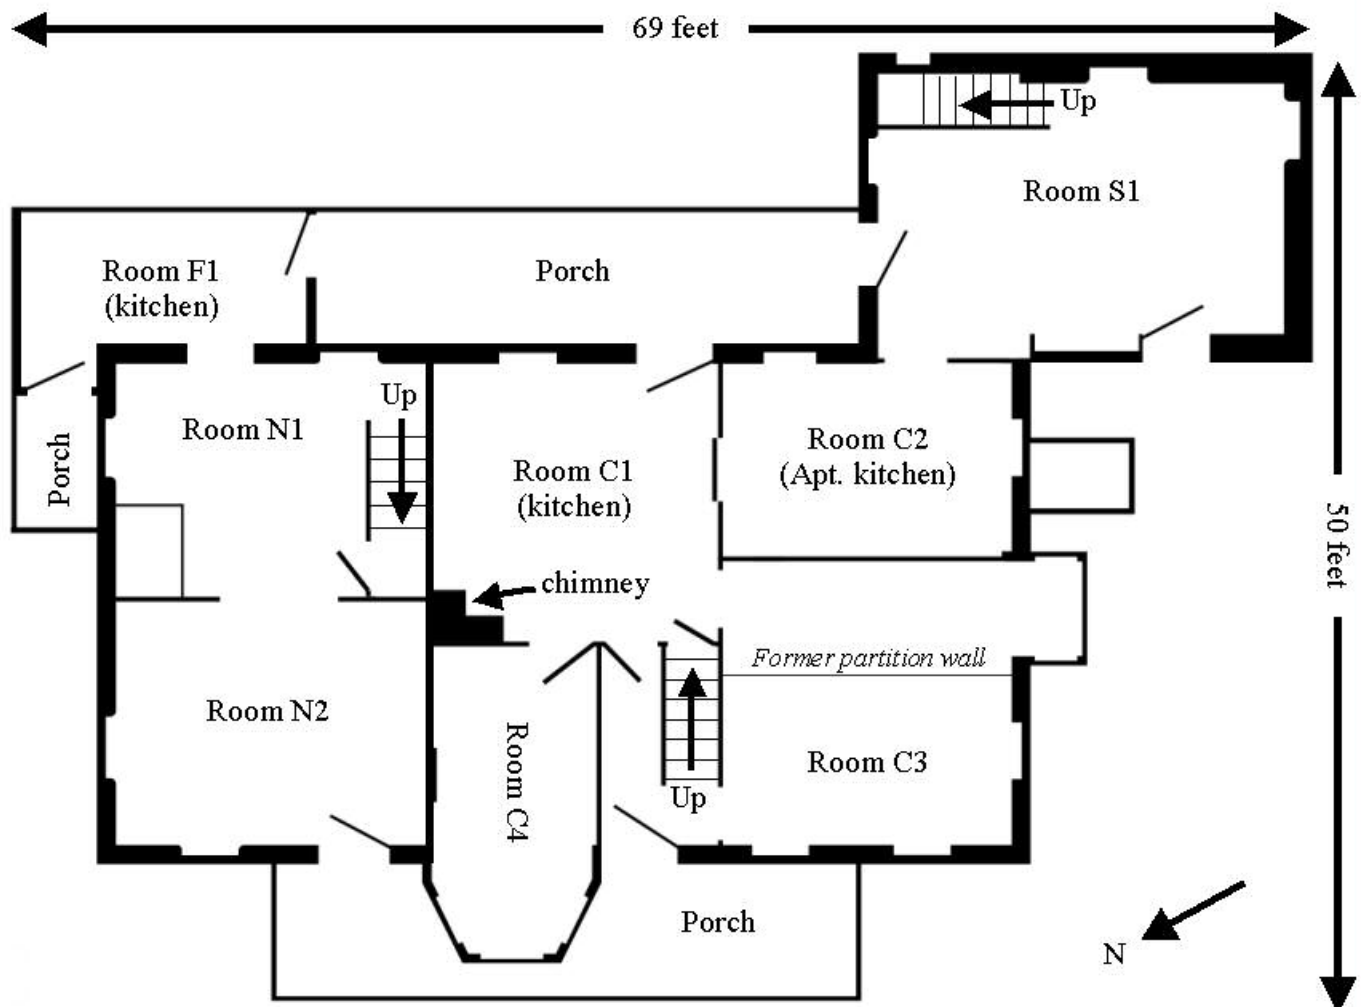
Figure 2. First floor plan.

The first floor consists of eight main rooms with ancillary rooms including hallways and stairs (see Figure 2). In general, the main block (center and north sections) has a rough center hall plan; the south section has a single room. Common features of the rooms are plastered ceiling and walls and tongue-and-grooved flooring, most of the latter being carpeted. Rooms are discussed below by section, moving from north to south.

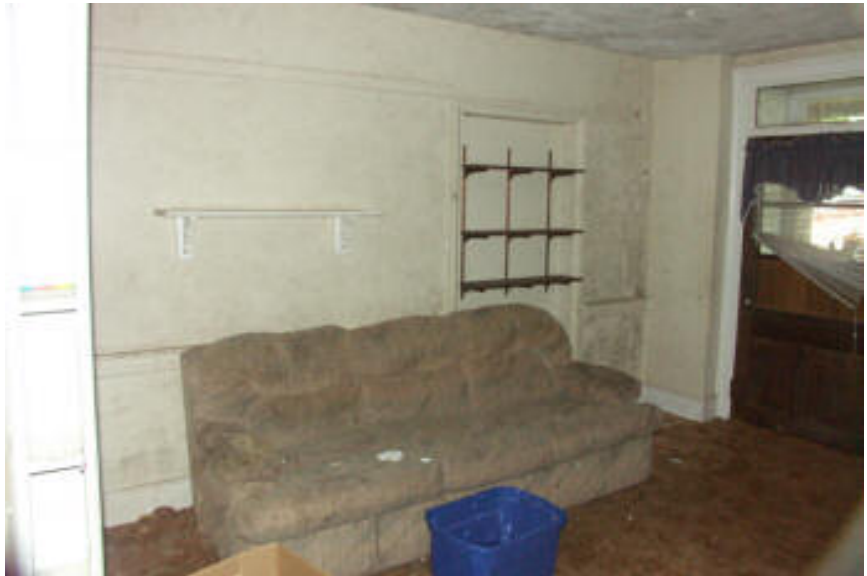
The north section has two rooms on the first floor. The entrance on the west elevation opens into Room N2 (Photo 13), which measures 13'1"x15'6". This room has a plastered ceiling and walls and a carpeted floor. A sealed door is located on the south wall which formerly opened into Room C4 of the center section. The windows on the north and west walls feature "cheeking," or rounding of the jambs. One of the more important features of the room is the chair railing, which was used in other rooms historically but has been removed. The east partition wall has a centered doorway six feet wide leading into Room N1 (Photo 14). The doorway has a stack of five narrow shelves on the ends of the partition wall.

**Photo 13. Room N2, North section, facing SW. Note the sealed door on south wall which originally connected to the center section.**

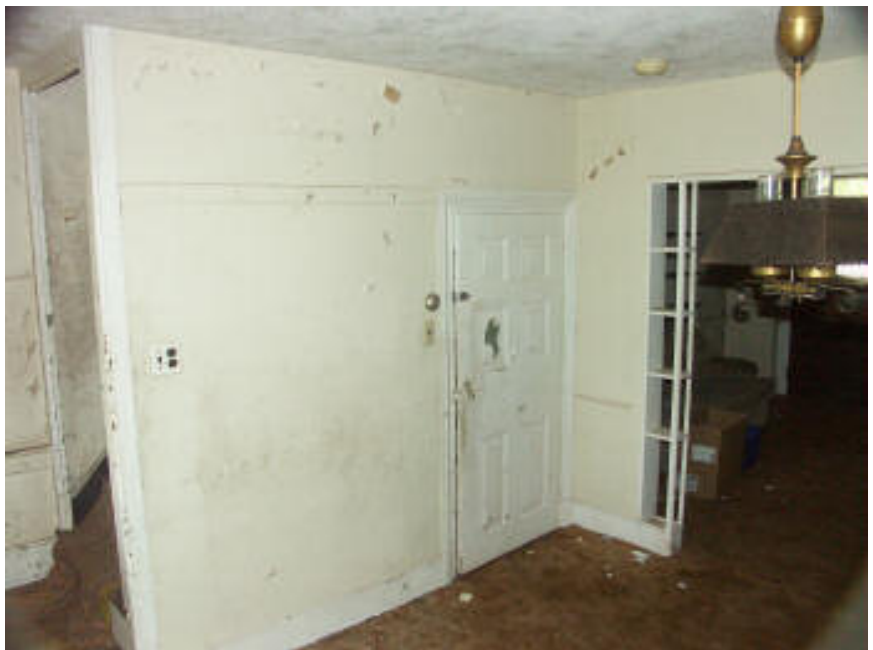
Room N1, encompassing the eastern half of the north section, has a plastered ceiling and walls and a hardwood floor. The room measures 12'6"x15'6", although the southern three feet of the room is mostly occupied by the stairs. Key features of the room are the cheeked windows, baseboard molding, and the chair rail. Changes in the flooring under the carpet in the northwest corner indicate the size of the former hearth. An original door on the south wall opens into the stairs to the basement located directly under the stairs to the second floor. An original doorway on the east wall leads into the frame section; this doorway's architrave has the same paneling as the front door, and the door frame on the outside (now inside the kitchen) has the same double

**Photo 14. Room N1, north section, facing SW. Note stairs to the second floor (left), doorway to basement stairs (center).**

original door on the south wall opens into the stairs to the basement located directly under the stairs to the second floor. An original doorway on the east wall leads into the frame section; this doorway's architrave has the same paneling as the front door, and the door frame on the outside (now inside the kitchen) has the same double

bulls-eye as found on the front door. Originally, this door would have led to the porch, which is now enclosed as the frame section.

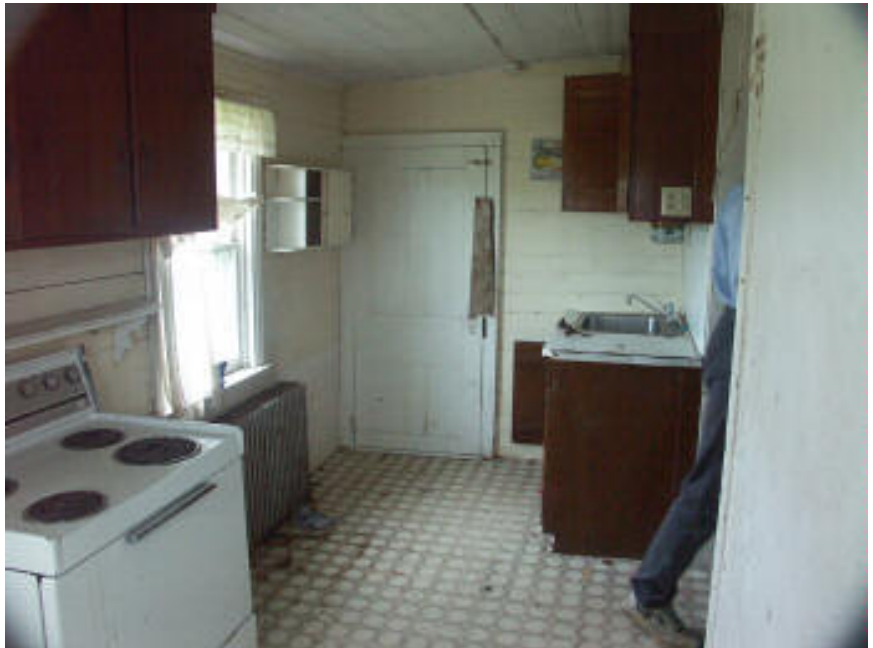
The interior of the frame section (Room F1) consists of a single room (a kitchen) is the interior of the frame section; which the enclosed porch section attached to the east wall of the north addition. Its longest dimensions are 15'x9'. It is accessed from the north section's original exterior door, a door from the small porch on the north end of the north section, and a door opening from the porch on the east elevation. The ceiling and walls are composed of beaded siding, and the floor is covered with vinyl. A sink is located along the western wall, and other kitchen appliances are located along the eastern wall.

Photo 15. Kitchen in frame section, facing south.

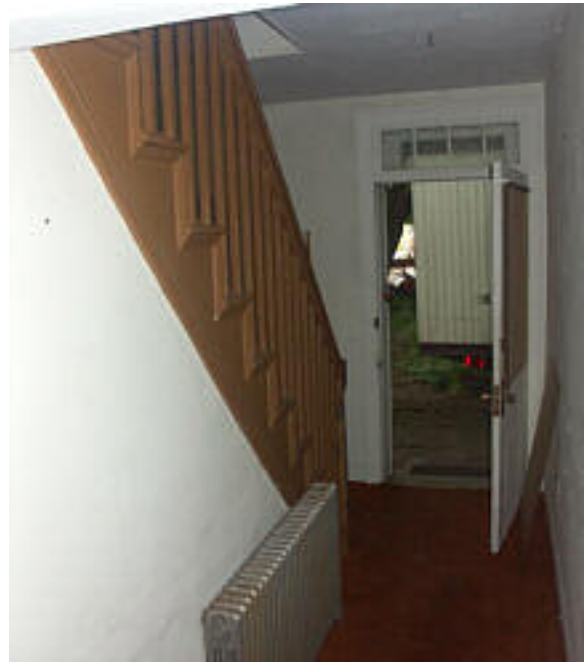
The center section is divided into four large rooms (Rooms C1, C2, C3, and C4) and an entryway. Common elements in these rooms include a plastered ceiling and walls, tongue-and-grooved hardwood floors covered with carpeting, and a simple baseboard molding, with exceptions as noted below. The building's main entrance, located on the west elevation south of the bay window, opens into the entryway (Photo 17). This space, measuring 6'5"x11'3", includes a plainly designed stair system to the second floor along the entryway's southern wall and a narrow hallway running east to the kitchen. The stairs form part of a stair stack connecting all four levels of the house. The stairs have a pine newel post and square balusters. The entryway has a door opening south into Room C3 (probably the former parlor) and a door on the east end opening into Room C1 (the kitchen).

Photo 17. View of entryway, facing west.

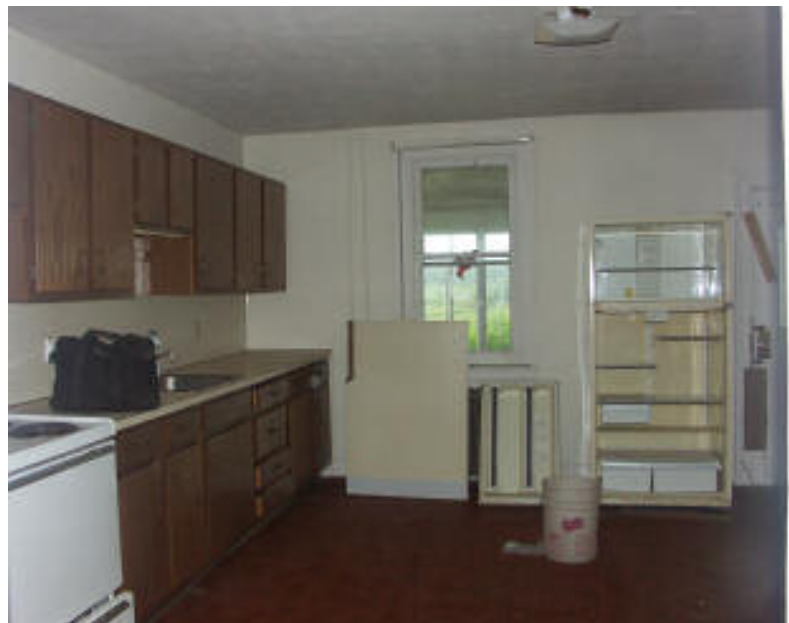
Room C1 is located in the northeast corner of the center section (Photo 18). It is a square room, measuring 14'10" on each side. This room served as the kitchen for the house and most recently for the middle apartment. It has a plastered ceiling and walls and has a vinyl floor. An L-shaped feature in the northwestern corner indicates the location of the plumbing stack and the remnants of the chimney. Three doors occupy most of the west wall of the room. The southernmost door opens into the stairs to the basement (under the formal stairs in the entryway). The center door opens into the entryway, and the northernmost door opens into Room C4. The southern wall historically had two doors, opening into Rooms C2 and C3.

Photo 18. Room C1, showing kitchen appliances.

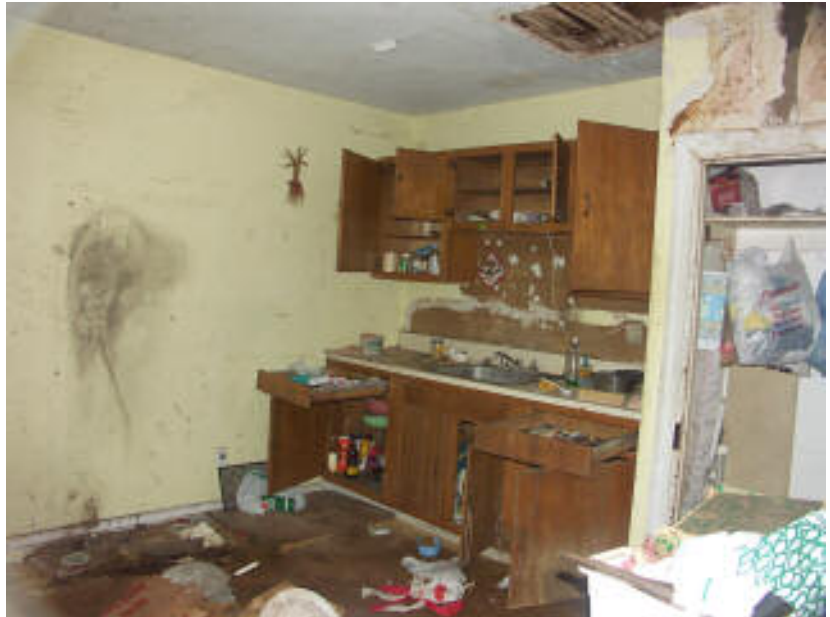
Room C2 is located in the southeastern corner of the center section (Photo 19). This room was partitioned off from the center section as the kitchen for the south section apartment. It measures 11'x15'2". It has a plastered ceiling and walls and a vinyl floor. Cabinets and the sink are located on the northern wall, and the larger appliances were located along the western wall.

**Photo 19. Room C2 in center section, facing NW.**

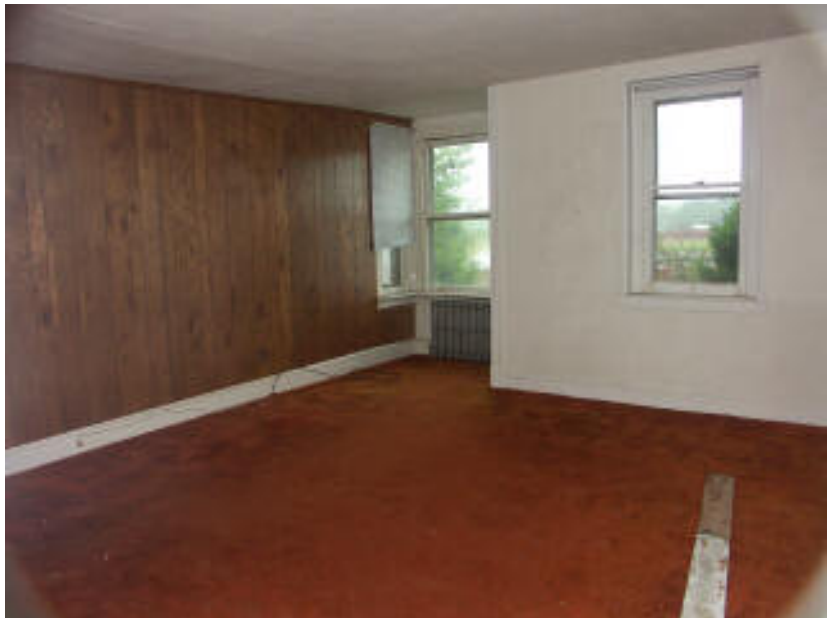
Room C3 (the parlor) is located in the southwestern corner of the center section (Photo 20). The nearly square room measures 15'2"x15'5". It has a plastered ceiling and walls, although the eastern wall is covered with faux wood paneling. The floor is carpeted. Markings on the ceiling indicate the presence of a former partition wall running north to south (indicated on the floorplan). Other markings on the south wall indicate the location of the original chair railing.

**Photo 20. Room C3 in center section, facing SE. Note the bay window on the south wall.**

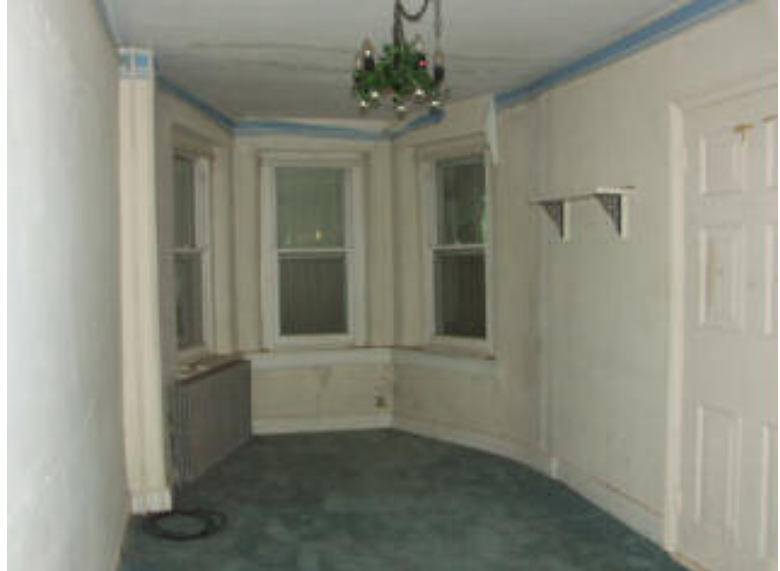
Room C4 is located north of the entryway and is accessed from Room C1 (Photo 21). This room, measuring 17'4"x9', incorporates the space made available by the bay window. Its randomness makes it an awkward room; it may have originally included the entryway. On its western end, a chamfer at the beginning of the bay indicates the original wall surface. The windows in the bay window appear to be original. A sealed door formerly opening into Room N2 is located on the northern wall. Ghost markings on the north and south walls indicate the former presence of a chair railing. This railing appears to have been roughly one foot wide, which is unusually wide for a chair railing.

Photo 21. Room C4, center section, facing west into bay window.

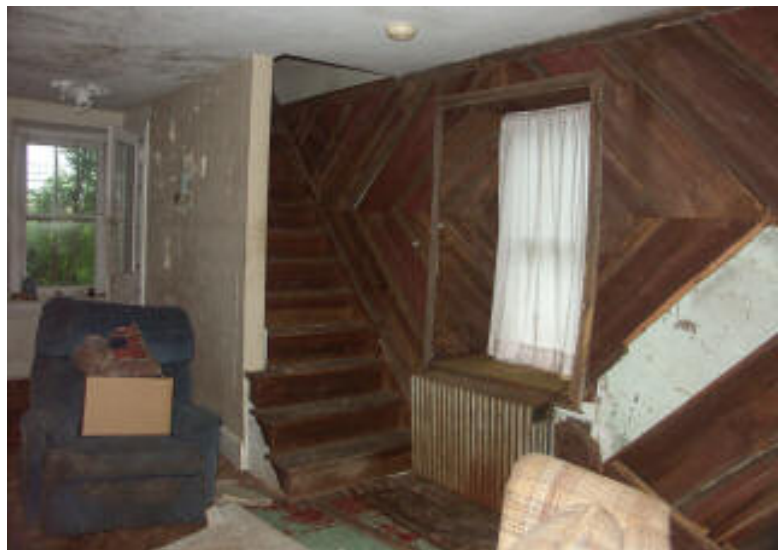
The interior of the south section and the Connection are combined into one room (Photo 22). This space, measuring 21'6"x13'6", was highly altered. The fireplace was removed, the stairs reversed, and the flooring and joist system was replaced. The room has a plastered ceiling and a carpeted floor. Three of the walls are plastered; the eastern wall is covered with a diagonal wood siding stained a dark brown. The stairs to the second floor occupy the northeastern corner, with a storage space under the stairs. The room has two doors leading to the exterior and one into the apartment's kitchen.

Photo 22. Interior of south section, facing NE. Note the diagonal wood treatment on the wall.
