Second Floor

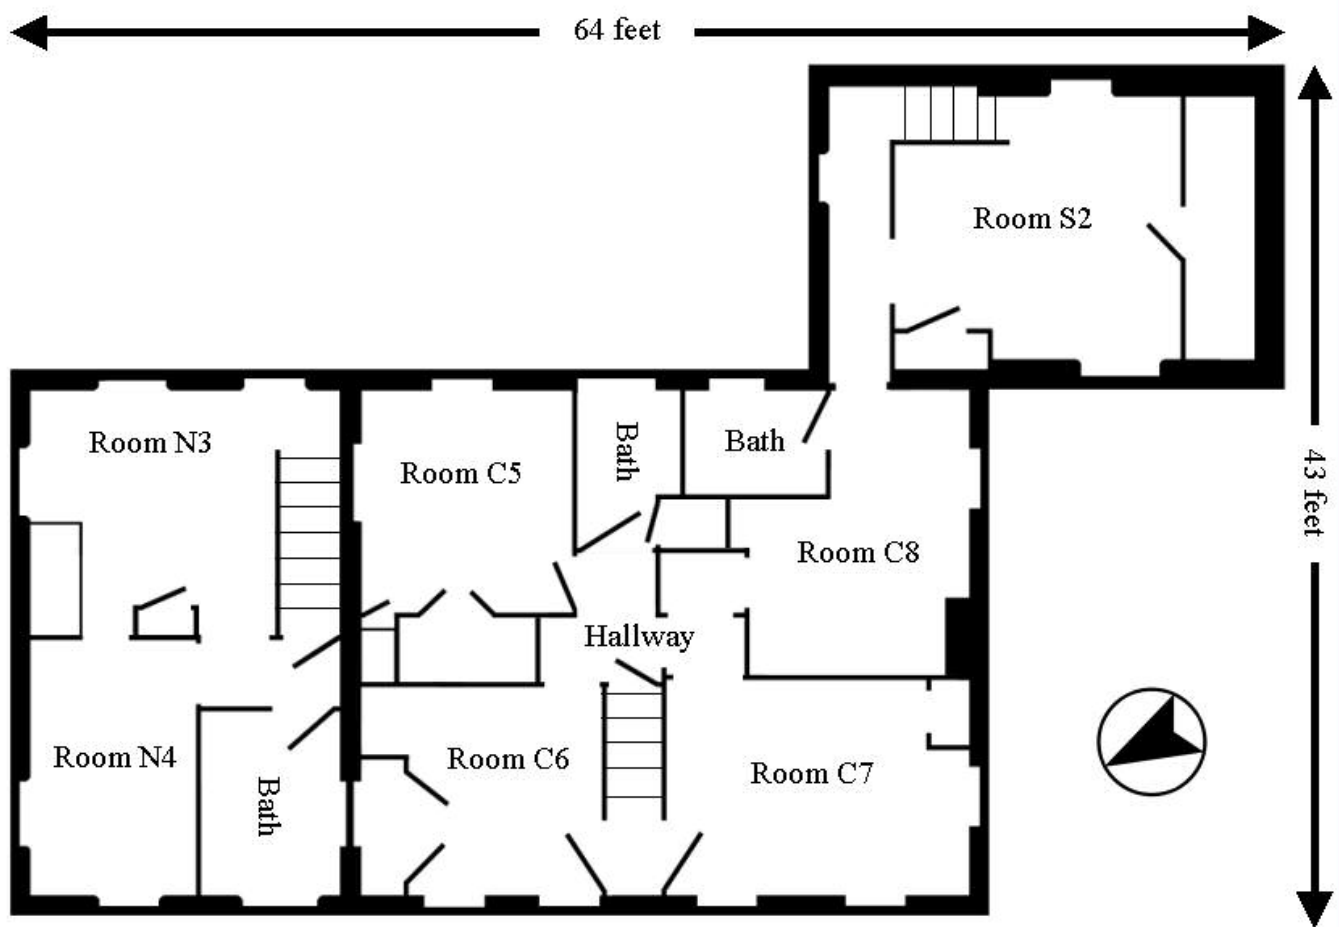
Figure 3. Second floor plan.

The second floor consists of seven bedrooms and three bathrooms. The three apartment units occupy primarily the same space as on the first floor, although the partition wall in the center section between the center unit and the southern unit is slightly different. The description follows the room designations in Figure 3 below. Common features of the rooms include plastered ceiling and walls, pegboards on the walls, and an exposed plank floor. Some woodwork in the center section has been removed by vandals.

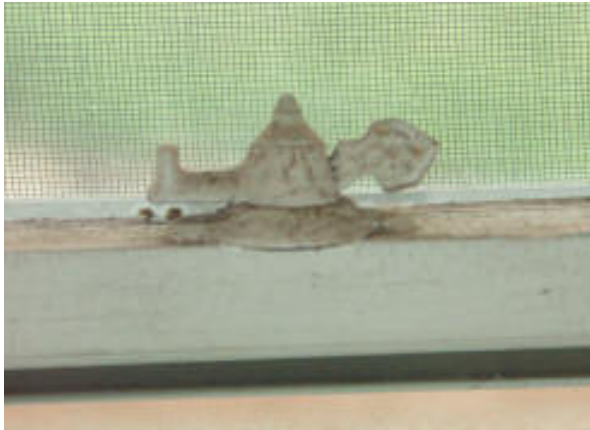
Photo 24. Victorian window latch in Room N4.

leading to other portions of the unit. Both Room N3 and N4 have pegboards on the wall. Windows in the section have Victorian hardware which is mostly still operable (Photo 24).

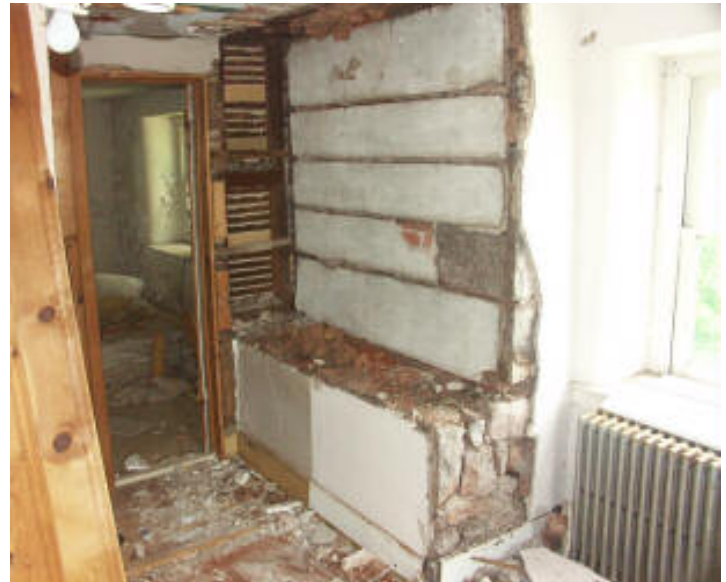
Photo 23. Remnants of chimney mass in Room N3.

been divided into a bedroom (Room N4) and a bathroom. Room N3 has the remnants of the chimney on the north wall (Photo 23). [Note: The mass extends to the attic; as such, it appears that the second floor joists and wall are supporting this remaining chimney mass. If this is the case, the chimney mass may be structurally unsound.] Since much of the framing has been removed from around the chimney, the summer beam supporting the attic joists is partially visible; it has vertical adze marks, an indication of the age of the beam. The wall surface between the chimney and the door leading into Room N4 has vertical lathe to accommodate shelving (lathe was usually installed horizontally). A cabinet is located on the west wall between the two doors

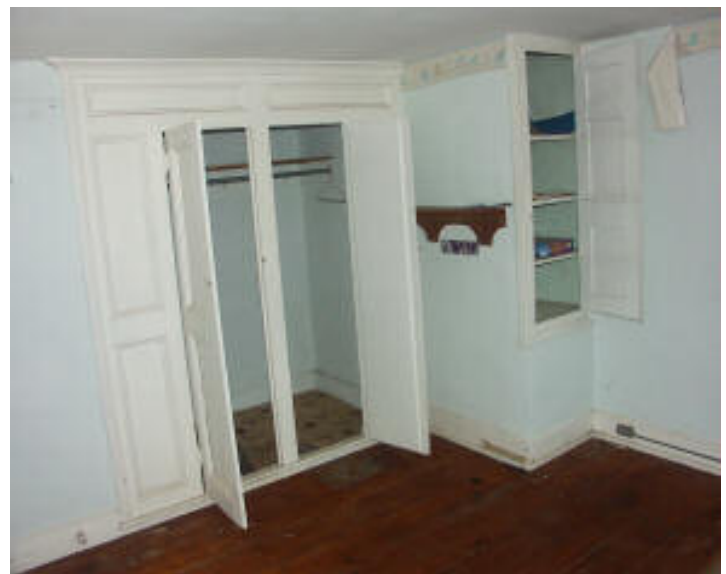
Photo 25. West wall of Room C5, showing two cabinets. The cabinet to the right has the only original door of the entire center section.

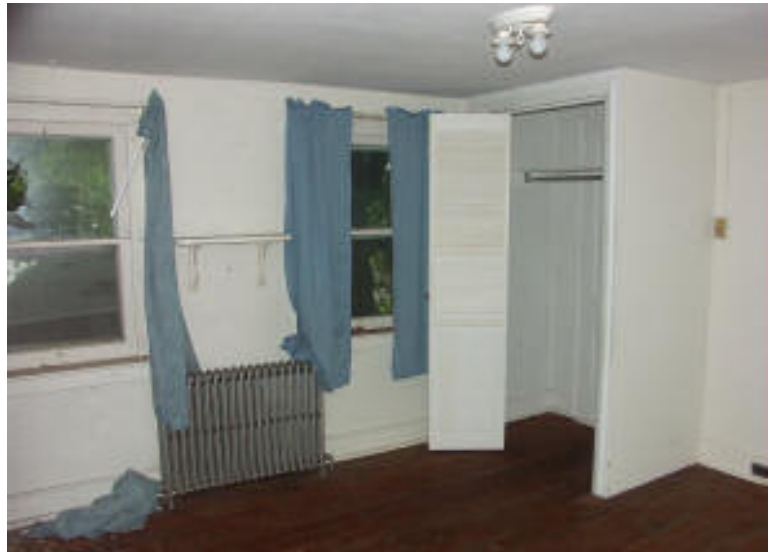
Photo 26. Room C6, center section, facing NW.

southern apartment unit. Rooms C6 and C7 on the western wall of the section have doors opening into the hallway and doors opening into the stairs to the first floor. Each room has a closet, and the closet in Room C6 covers a sealed door formerly opening into the north section (Photo 26). Room C5 in the northeast corner of the center section has a large closet on its west wall with three floor registers (Photo 25). A small cabinet north of the closet has a Federal Style door which is probably the only original door remaining in the center section. The bath on the east wall appears to have been partitioned out of Room C5; a short hall leads from the hallway in the center of the section and has a door leading north into Room C5 and a door leading east into the bathroom. A closet is located on the south wall of the bathroom.

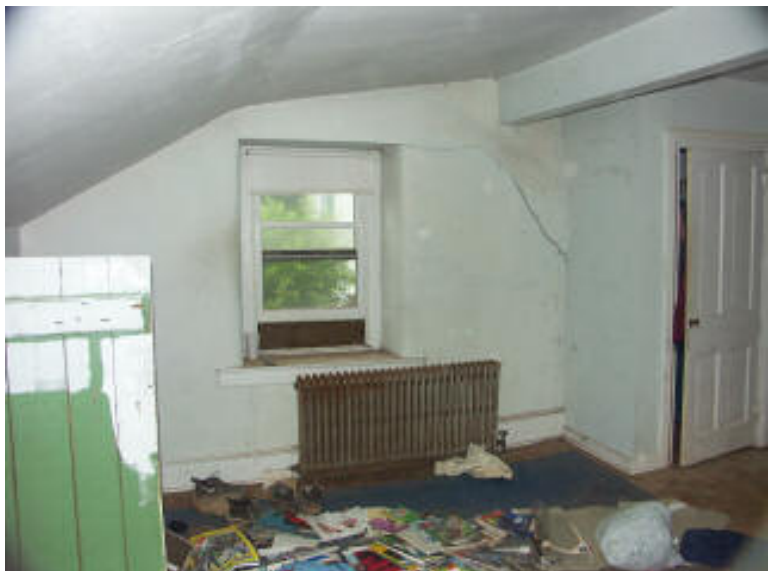
Photo 27. Room S2, facing west. Note the slope of the ceiling, which is attached to the bottom of the rafters.
