## Basement

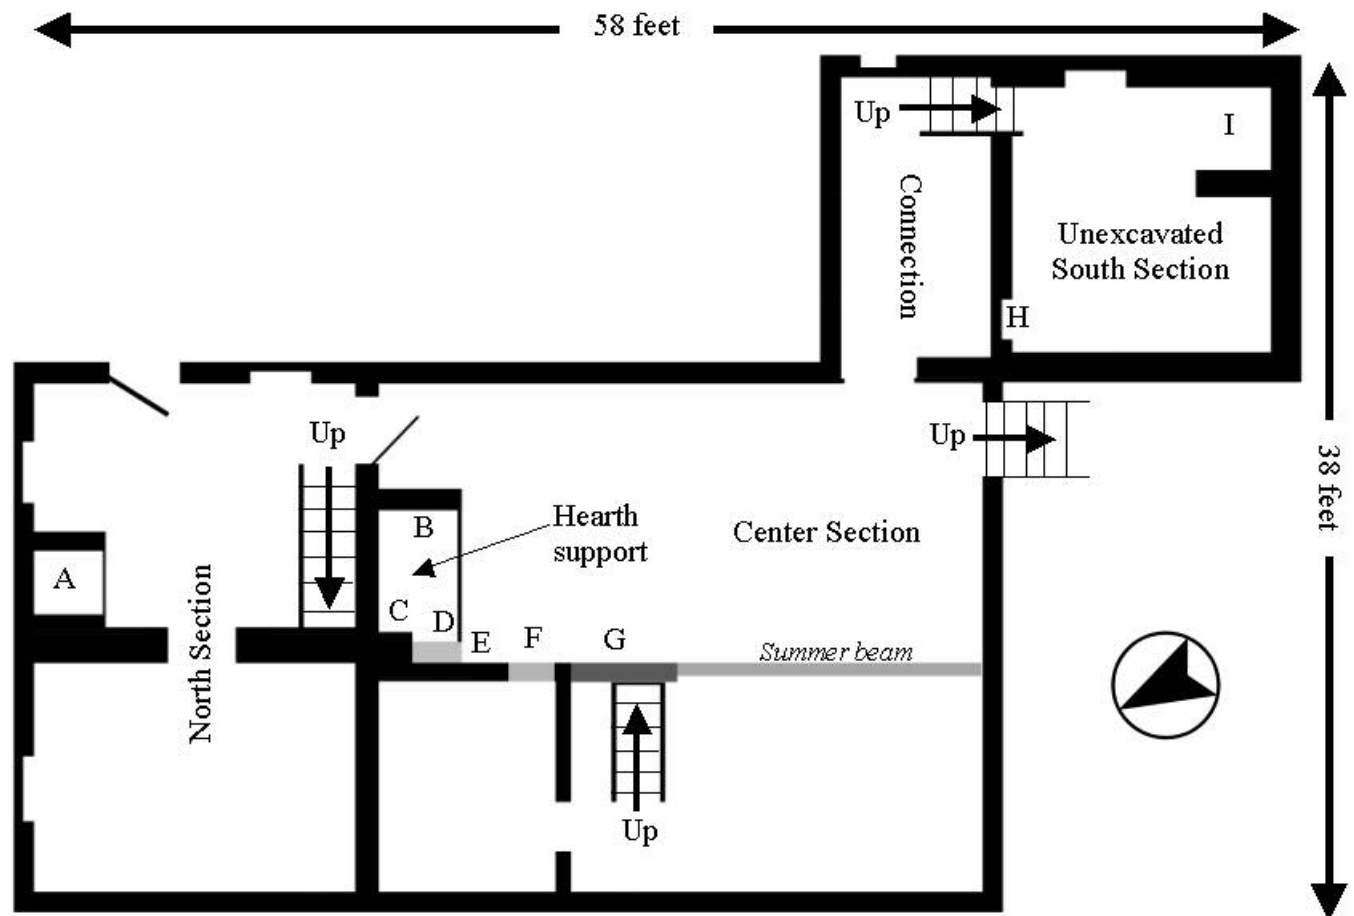
The basement is comprised of five rooms (see Figure 6) with an overall interior measurement of 58x38 feet. All sections of the house have a basement except for that under the south section, which is unexcavated. Common basement elements include the dirt floor, stucco over stone walls, and exposed joists forming the ceiling. The north section is described first.

Figure 6. Floorplan of the basement. Lettered items are identified in the text.

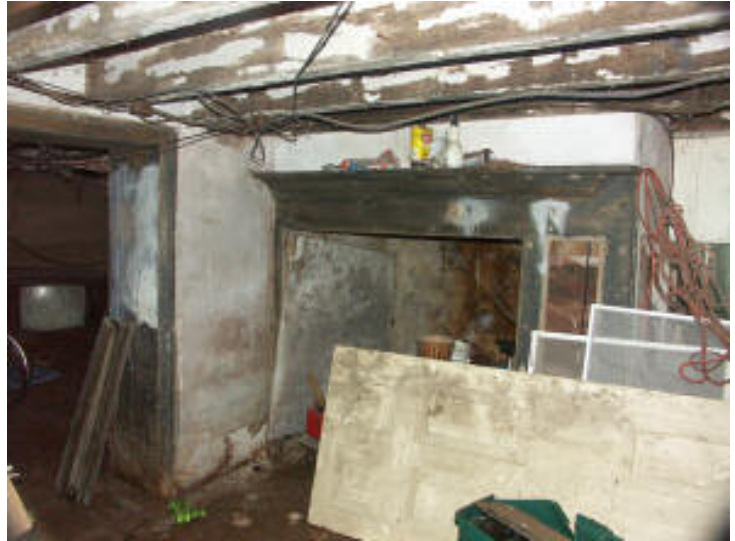
**Photo 31. Kitchen hearth in basement of north section, facing north.**

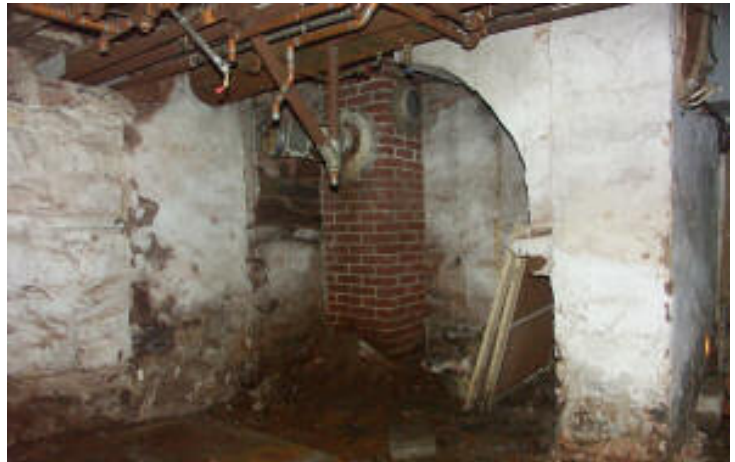
A stone wall extends south through the center of the basement of the center section. This stuccoed element appears to consist of a former freestanding pier at its southern terminus which has been extended to the north and abuts the south end of the western wall of the hearth support. [It has been suggested that it was part of the foundation of an earlier building on the location, but there is no evidence to support this argument.] A former passageway (F) between the pier and the hearth support, leading into the northwest room, was filled in, possibly using the stone removed from the hearth support.

**Photo 32. Altered fireplace hearth support in center section, showing the 20<sup>th</sup> century brick oil furnace flue.**

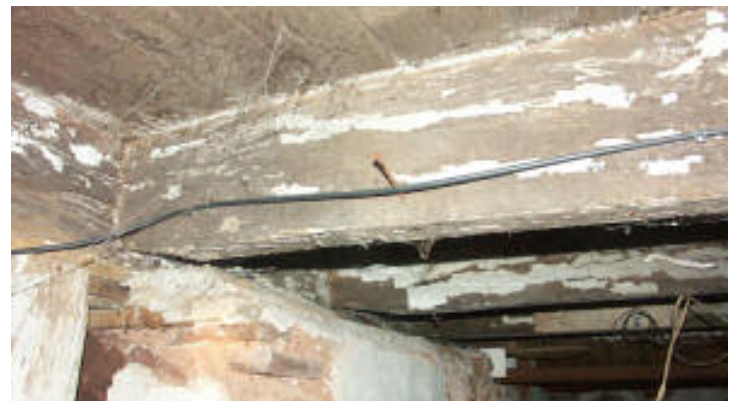
The original pier supported the center of the summer beam. Today, the northern half of the summer beam rests on the top of the stone wall. The thirteen exposed joists forming the ceiling of the basement of the center section are connected into the summer beam by a mortise and tenon joint. Several of these joists are chamfered at their intersection with the summer beam to accommodate a sill plate on the top of the stone wall.

**Photo 32a. Shaped joists rest on a sill plate on the top of the stone partition wall in the basement.**

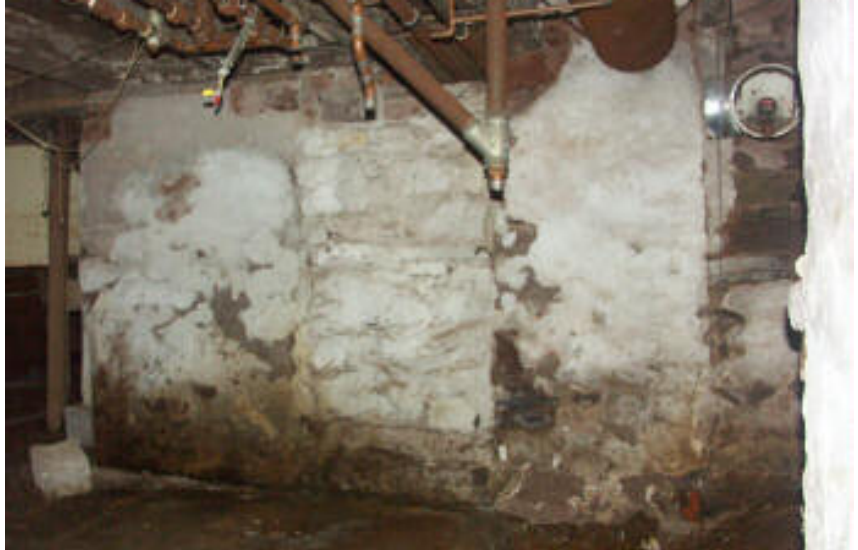
**Photo 32b. Stone wall in basement of center section, showing the three sections south of the hearth support.**

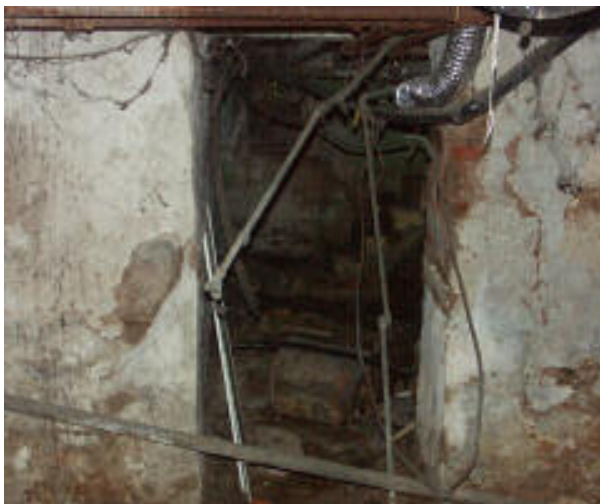
East of the bulkhead passageway is a doorway on the east wall leading into the basement of the connection (Photo 34). The basement under the connection measures 7'7" wide. Stairs along the east wall lead to the first floor, although markings on the walls indicate that the stairs formerly ran in the other direction (possibly when the flooring was replaced). A small window in the south wall near the southwestern corner (H) allows a view into the unexcavated area

**Photo 34. Entrance into connection, facing**
