Architectural Element: Interior Baseboard and Chair Molding

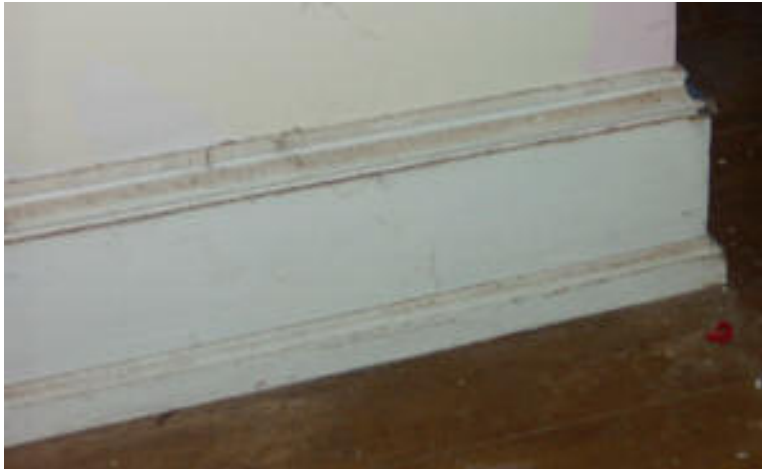
A spiked baseboard molding was installed in several rooms in the late nineteenth and early twentieth century (Molding 5). This Colonial Revival Style of baseboard molding is similar to

Molding 4 but with a more detailed shoe and a spike over the head. It was used on the exterior of the porch on the west elevation, where it wraps around the bay window. On the interior, this molding type is found on several of the newer partition walls added when the house was divided into apartments (such as Rooms C5 and C8).

Molding 6. Spiked baseboard molding, found on the second floor of the center section.

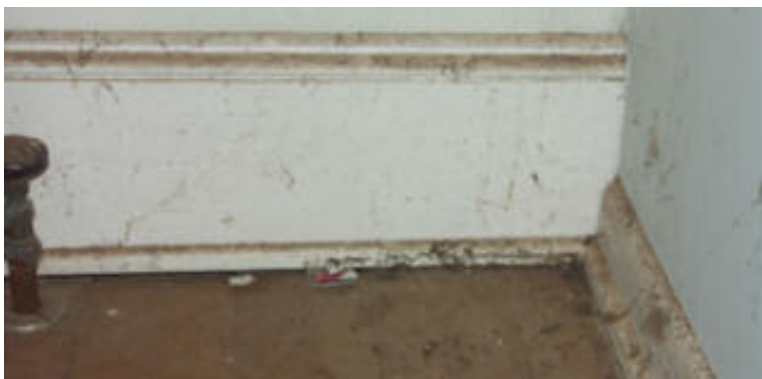
In the early twentieth century, another type of baseboard molding was installed (Molding 7). It consists of a beveled head (rather than a beaded head) and a shoe. This molding is visible in the second floor of the south apartment unit, including both the south section and the room in the southeastern corner of the center section, where it is illustrated in Molding 8. This molding is much smaller than that found elsewhere in the building.

Molding 8. Junction of spiked baseboard molding and beveled molding, found on the second floor of the center section.
