APPENDIX A

Preliminary Historic House Inspection

Field Report of inspection conducted on 10/2/05 with Dianne Cram, Wentz Farmstead Administrator, & Norm Glass, Historic Restoration Contractor

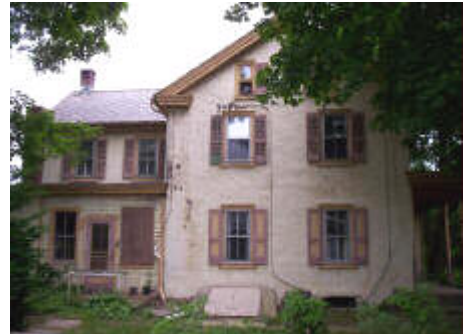
Southwest Side

- Large cistern found located under concrete porch floor on the southwest side of the house adjacent to the summer kitchen and near the entrance to the kitchen.

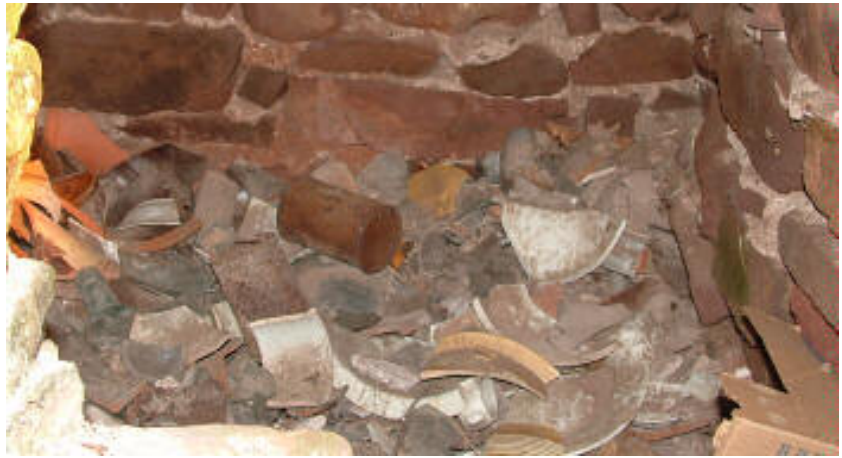
- The interior follows a simple center hall plan, one room deep on each side of hall. Many of the interior walls are finished with wood lath and plaster.
- Main entry into small center hall with stairs directly in front of main entry with parlor to the right and dining room to the left.
- Artifacts found in bake oven cleanout including various redware, yellowware, & whiteware fragments. Most accessible pieces were moved into the house for security. The access opening into this cleanout should be secured.

Artifacts in bake oven cleanout.
