II. Physical Description

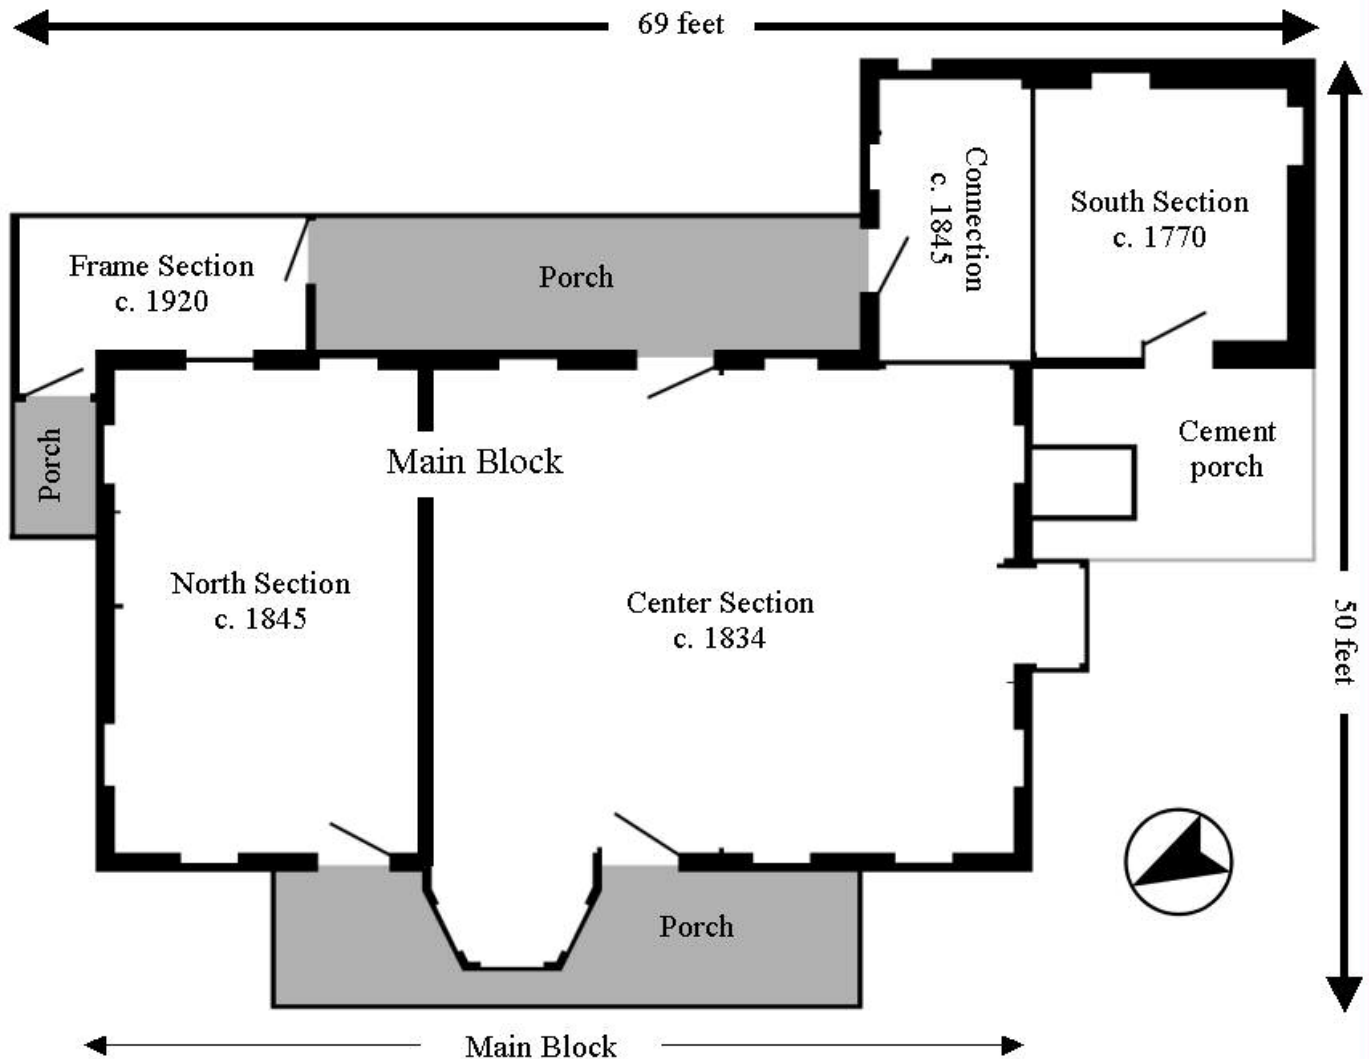
Figure 1. Footprint of the Hunsicker House. Open porches are shaded.

The Hunsicker House is comprised of a two-part main block, a two-part south block, and a frame section (See Figure 1 and Photo 1). Its overall dimensions, including all sections and porches, are 69'x50'. The main block is comprised of a two-story, four-bay brick center section (c. 1834) and a two-story, two-bay stone north section (c. 1845). The south block is comprised of a two-story, two-bay stone south section (c. 1770) and a two-story stone section that
