Attic

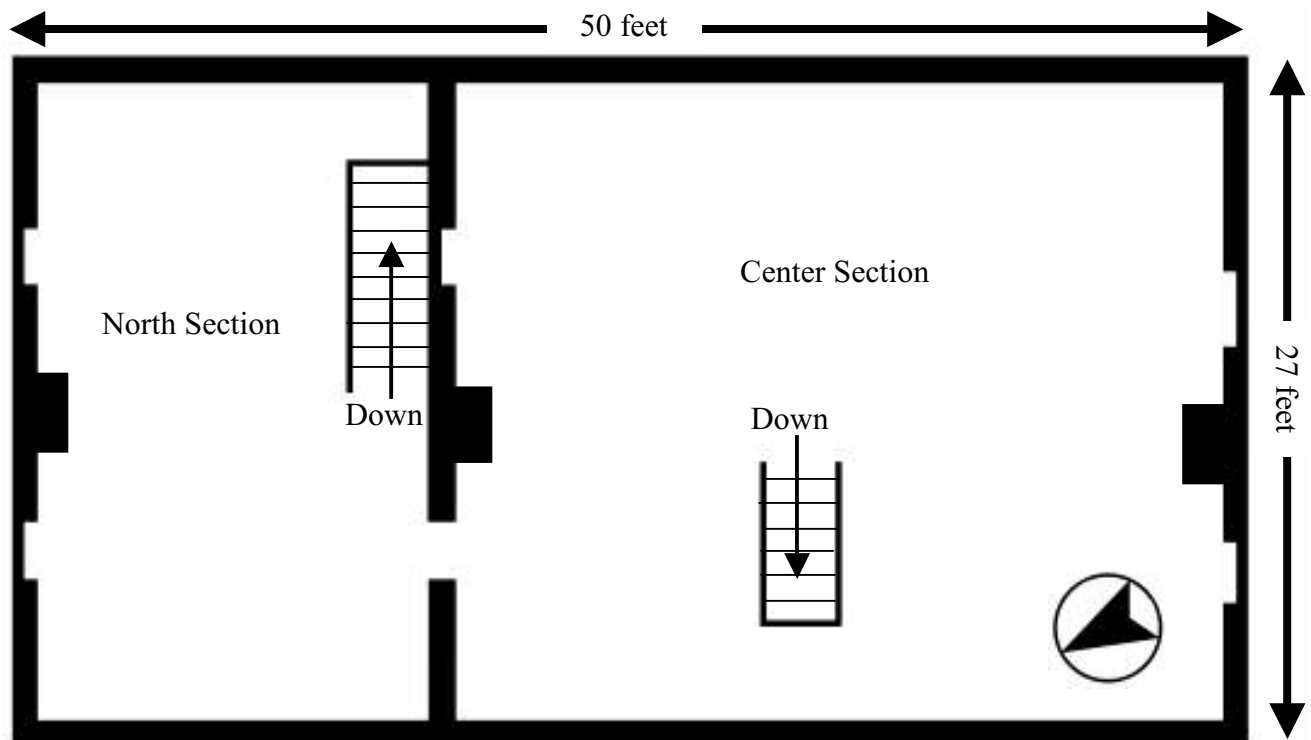
Figure 4. Floorplan of attic.

The attic spans the third floor space of the main block. The rafter system in the two sections is nearly identical, providing evidence that the two sections were constructed within a few years of one another. The attic has an overall dimension of 50'x27', although it is divided by the brick north end wall of the center section. The two end chimney have been reduced below the roofline, although the center chimney is still in use (Photo 28). See Figure 4 for a floorplan of the attic.

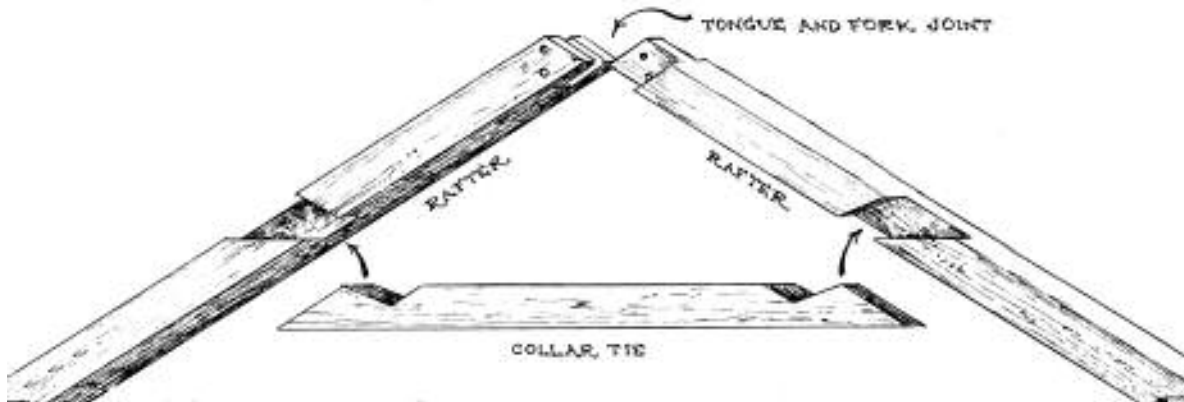
Figure 5. Typical “tongue and fork” rafter system, adapted from C. Keith Wilbur, *Homebuilding and Woodworking in Colonial America* (Old Saybrook CT: The Globe Pequot Press, 1992), p. 36.

The rafters are attached at the ridge with a technique called the “tongue and fork” joint, an eighteenth century means of construction. Rather than having a ridge board, the upper ends of the rafters are pegged together (see Figure 5). The center section has thirteen rafters, while the north section has seven. Most rafters are braced by collar beams; two of the collar beams have been removed from the center section. This rafter and collar beam system is joined with square pegs. In the latter nineteenth century, possibly when a slate roof was installed, a set of posts was installed to support the joint

between the rafters and the collar beams. These posts are nailed to the joists, not pegged.
